1280

January 31, 2001

**Summary Geotechnical Report: Post-construction  
SR 443 (Delaware Avenue) Landslide at Normans Kill  
Elsmere (Bethlehem), NY**

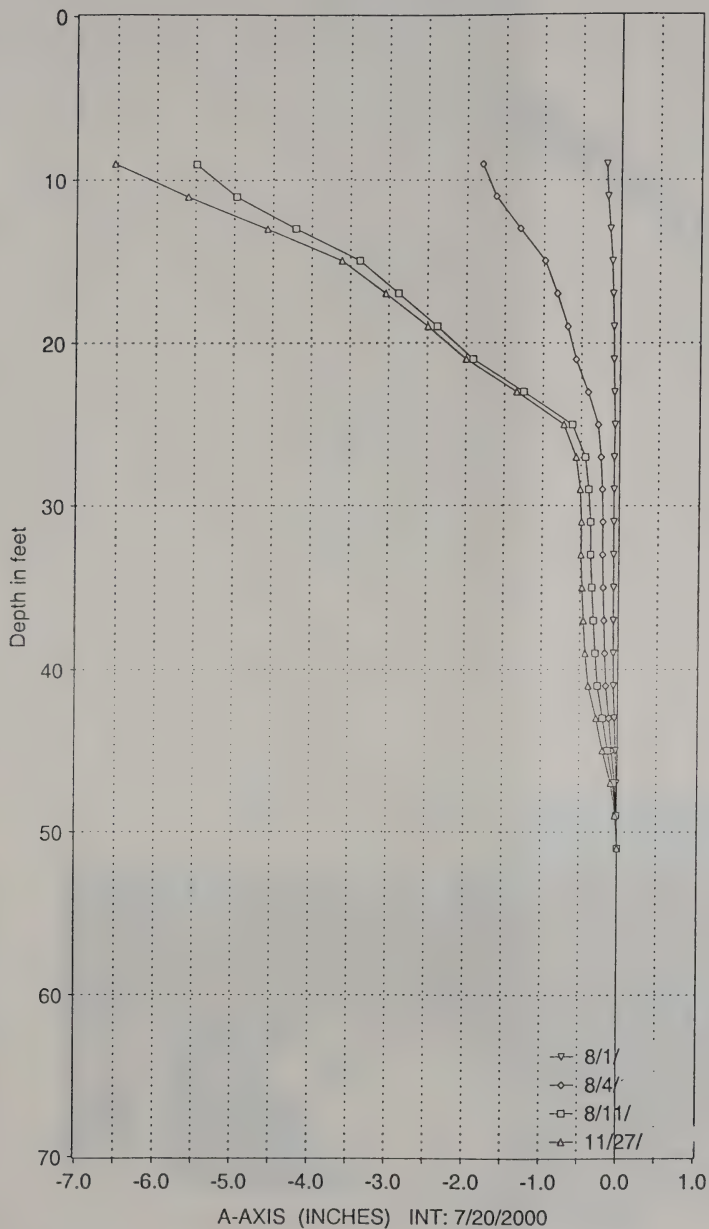
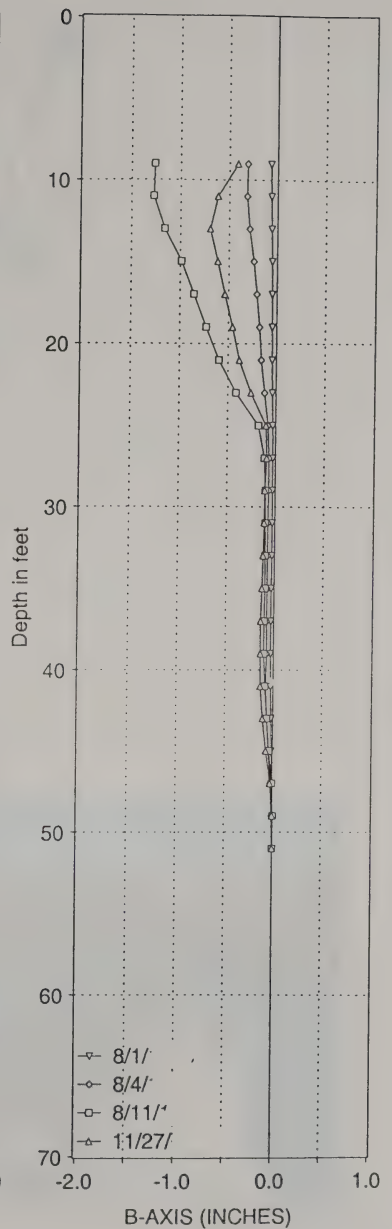
FIG. 1

The inclinometers in the slide mass have not shown movement since the slide area was re-graded. Refer to Photos 1 and 6 for locations of instrumentation groups. The inclinometers showed movements early during emergency construction. Refer to Figure 1 for a plot of inclinometer-measured ground displacement (SI 142 J, near the slide toe). This plot shows that the slide moved as viscous fluid from the ground surface down to a depth of approximately 25 feet, with an additional small increment of movement near the bottom of the inclinometer casing (depth range of 41 to 49 feet). The pavement above the headscarp does not show any signs of slide-movement cracks or scarp retrogression.

BORING B-16  
CASING 142 J  
INCLINOMETER PLOT  
LOCATION B-16

We recommend that the inclinometers be monitored at least every three months over the next year, and more often if ground movements are suspected. The groundwater conditions might become elevated following spring recharge and periods of sustained precipitation (significant rainfall over several days). The piezometers should be monitored monthly and whenever extreme wet periods occur (unusually high amounts of sustained precipitation or peak stream flows). Alternatively, data loggers could be attached for continuous readings.

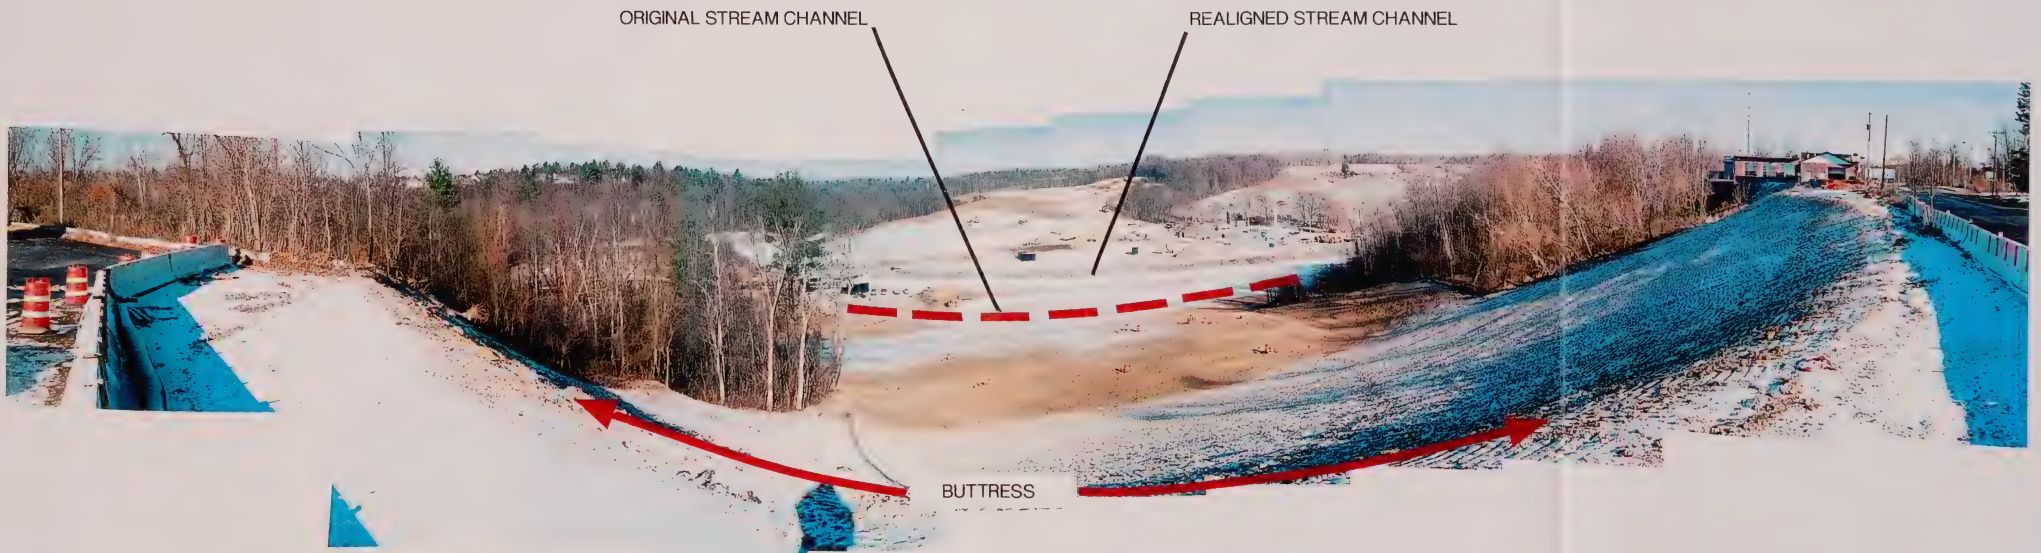
The evaluation of mitigation measures is based on the conditions observed during the December 9<sup>th</sup> reconnaissance. No stability analyses were performed. Photographs 1 through 18 (attached) show the observed conditions. Photo 1 shows a panoramic view of the landslide from Delaware Avenue looking north to the Normans Kill stream. The subsequent permanent earthwork has generally buried the initial emergency measures. The riprap along the realigned stream channel is now being covered with soil (for non-geotechnical reasons). The counterberm filling of the interim stream channel, in addition to the slide debris in the original stream, has added significantly more resistive weight to the slide toe. The slope of the counterberm surface is gentle to promote surface drainage (about 3% slope), and together with the riprap in the relocated stream channel should provide a stable stream bank. Photos 2, 3, and 4 show various views of the counterberm and realigned stream channel.

The final buttress was completed using light-weight pumice rock fill and is generally stable in appearance, except for local runoff erosion near the west end (refer to Photos 1 and 5). Diverting the surface runoff flow could mitigate the surface erosion by piping the collected water away from the steep slope. Alternatively, the erodable slope could be reinforced by installing a geosynthetic erosion control mat made specifically for runoff conditions.

PHOTO 1: PANORAMA OF SLIDE AREA LOOKING NORTH FROM DELAWARE AVENUE.

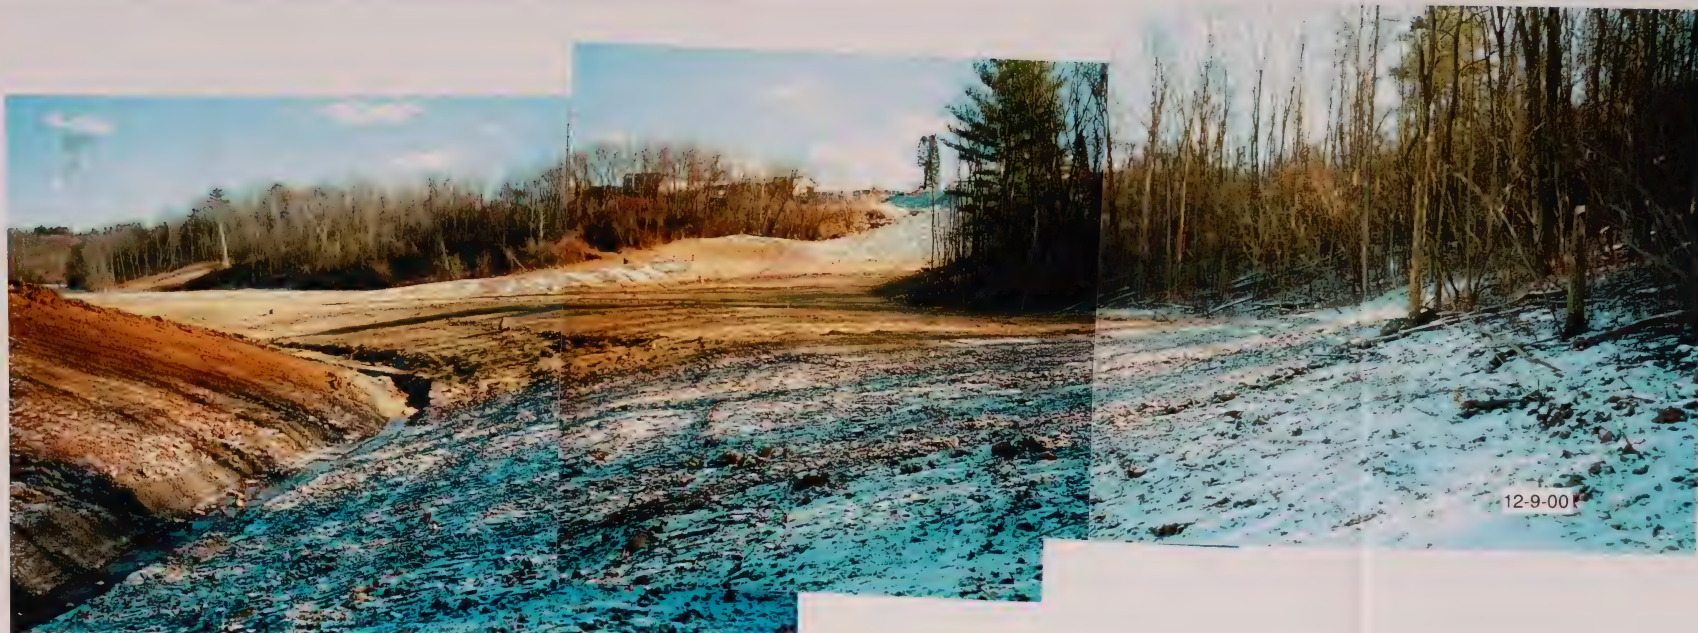
The counterberm consists of a granular fill placed within the interim stream channel and a cover of fine-grained soil that is relatively impermeable and covers the trench drains. Groundwater pressures within the slide toe and counterberm are

PHOTO 2: LOOKING EAST. NOTE OLD SLUMP FEATURES IN TREED AREAS. NEW COUNTER BERM FILL PLACED AT TOE OF SLIDE. THE FILL COVERS THE FORMER SEEPAGE AND WET AREAS.

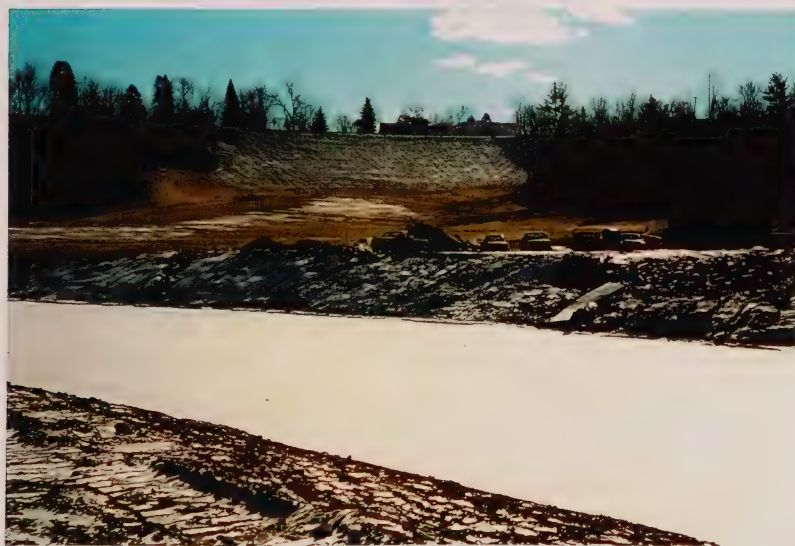
PHOTO 3: LOOKING SOUTH AT LANDSLIDE. NEW REALIGNED NORMANS KILL STREAM CHANNEL IN FOREGROUND. NOTE THE FLAT SLOPE FORMED BY THE COUNTER BERM. THE ORIGINAL STREAM CHANNEL WAS LOCATED BEYOND THE PARKED VEHICLES.

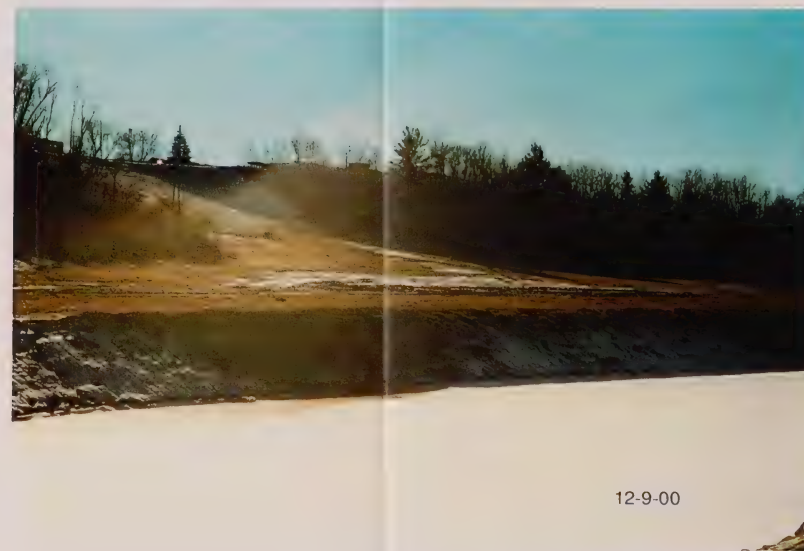
PHOTO 4: LOOKING SOUTHWEST AT LANDSLIDE. COUNTERBERM AND NEW REALIGNED NORMANS KILL STREAM CHANNEL IN FOREGROUND.

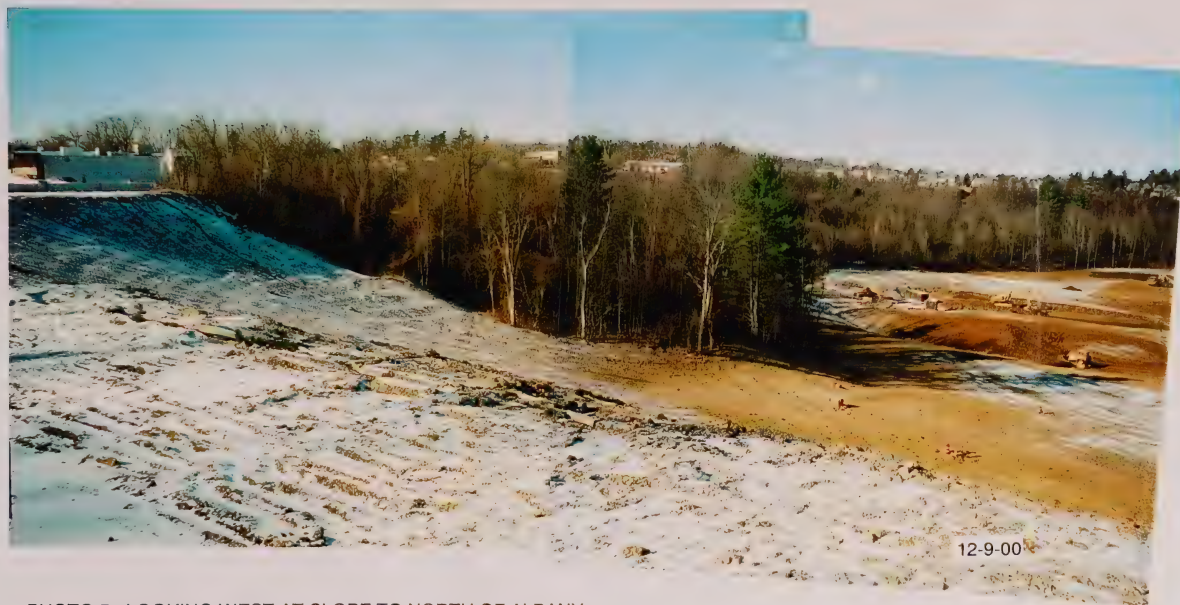
PHOTO 5: LOOKING WEST AT SLOPE TO NORTH OF ALBANY MEDICAL CENTER. NOTE THE OLD SLIDE FEATURES IN TREED AREA. HEADSCARP AREA WAS BUTTRESSED WITH ROCK AND PUMICE, AND IS NOW COVERED WITH SOIL FOR REVEGETATION. NOTE THE EROSION RILL NEAR THE WEST END OF THE UPPERSLOPE, WHERE CONCENTRATED SURFACE RUNOFF IS OCCURRING. CONSTRUCTION EQUIPMENT TO THE NORTH IS WORKING ON THE ALBANY WATER PIPELINE.

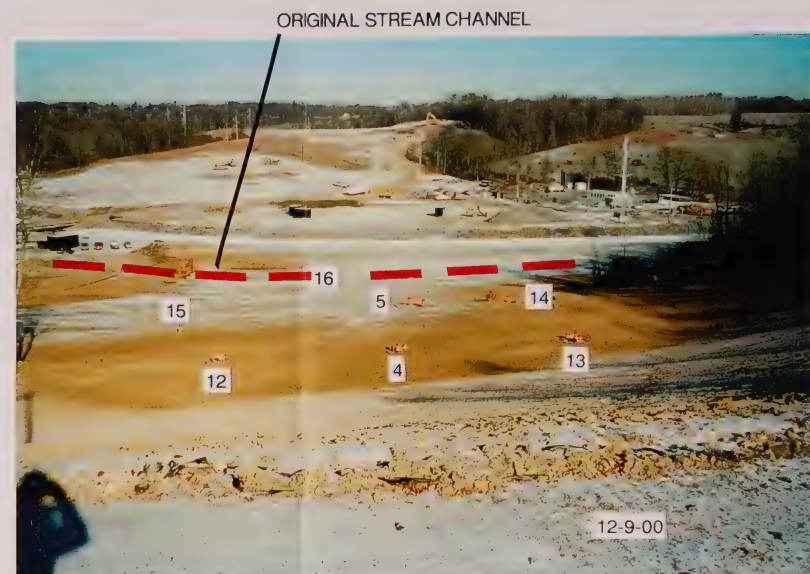
Piezometers at the boring B-15 location (west central slide area) are not functioning; however, the instruments at boring locations B-5, B-12, and B-14 (SI #'s 142 I, E & J) should provide sufficient information for this location of the landslide (refer to Photo 6 for instrument locations). The inclinometers at boring locations B-4, B-5, and B-16 are in the centerline of the landslide and appear to be stable and capable of further monitoring.

PHOTO 6: CENTRAL AREA OF LANDSLIDE, LOOKING NORTH. NOTE THE 3 MIDDLE AND 3 UPPER ORANGE BARRELS, WHICH MARK THE LOCATIONS OF GEOTECHNICAL INSTRUMENTS. THE LOWER MOST INSTRUMENTS (#16) ARE LOCATED OVER THE BURIED ORIGINAL STREAM CHANNEL.

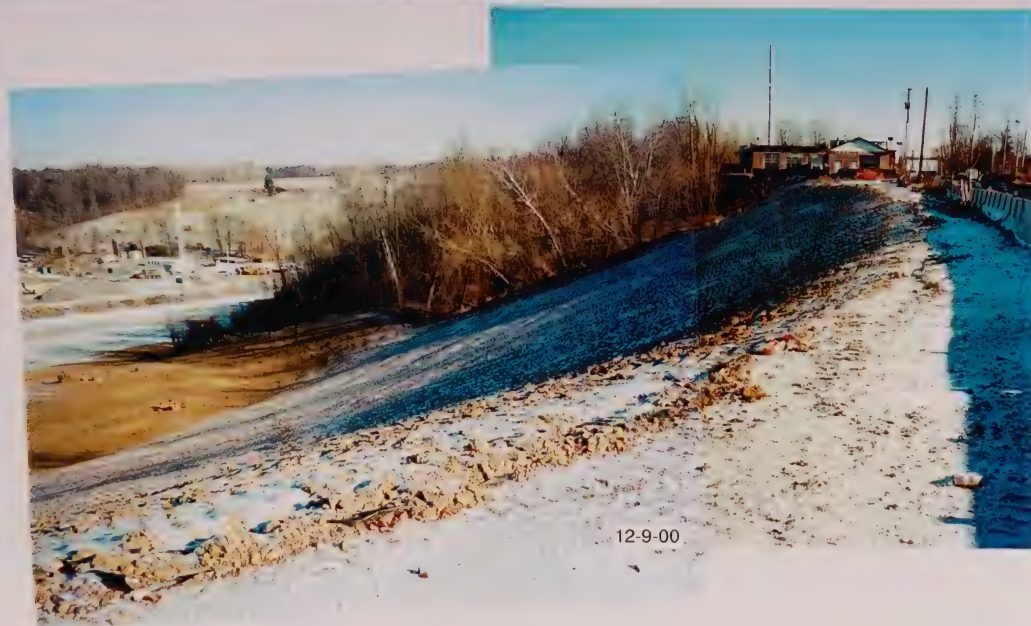
PHOTO 7: LOOKING EAST. EAST SIDE OF LANDSLIDE WITH JIFFY LUBE IN BACKGROUND. NOTE THE ANCIENT SLUMP FEATURES IN TREED AREA AND COUNTER BERM ON LEFT.

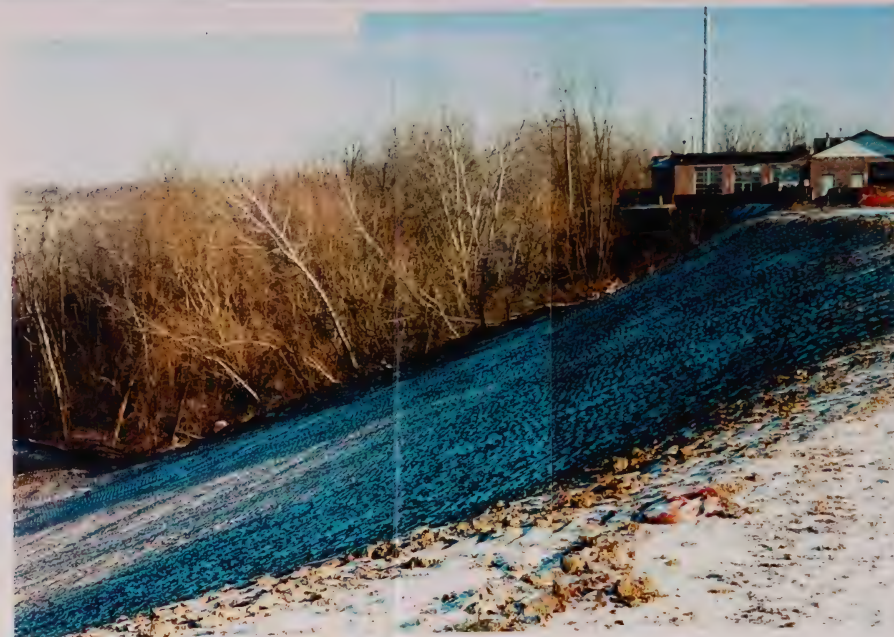
The ground slopes below the Hoffman's Jiffy Lube shop, and the Powerline easement to the east, exhibited less wetlands / seepage than what was observed in May and June. The survey monitoring data provided by the Jiffy Lube owner was limited to a few dates. There was no observable evidence of recent slide cracks or slumping. The counterberm and riprap placed at the stream bank should add resistance to the toe of this slope and make it more stable than before. Photos 7 through 10 show features at the east edge of the slide and at the slope below the Jiffy Lube. Data has not been received for the monitoring points in the Powerline easement. Photos 11 through 14 show slope features and improvements (riprap) made near the Powerline easement.

PHOTO 8: CLOSE UP VIEW OF SLOPE BELOW JIFFY LUBE.

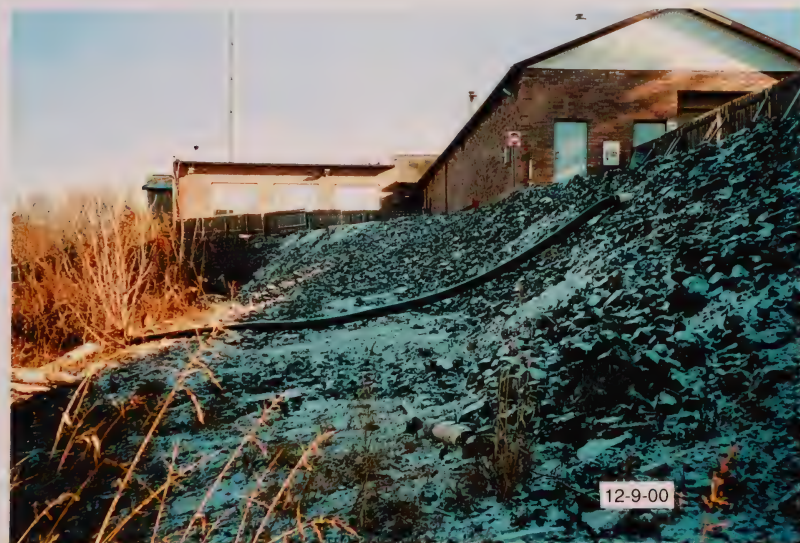
PHOTO 9: LOOKING EAST AT JIFFY LUBE. NOTE DISCHARGE PIPE. ROCK FILL REPLACED THE WESTERLY SECTION OF GABION WALL.

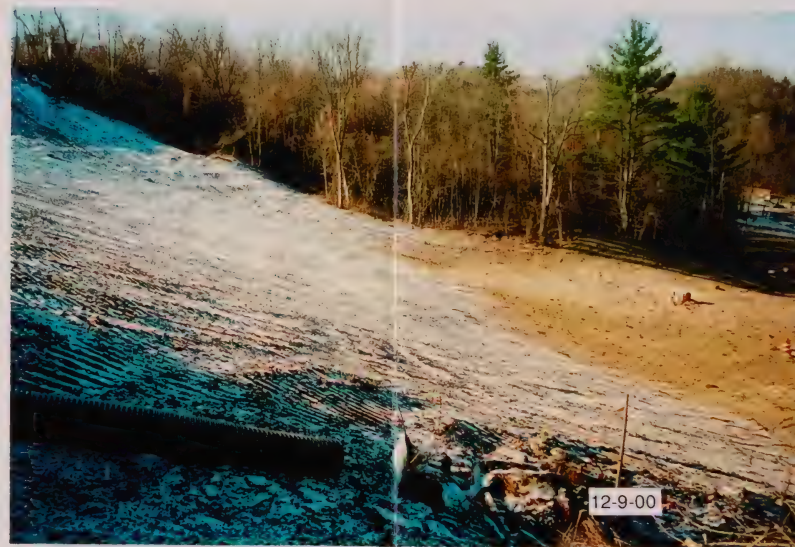
PHOTO 10: LOOKING WEST. DISCHARGE PIPE FROM JIFFY LUBE IN FOREGROUND (NO WATER IN PIPE DEC. 9, 2000).

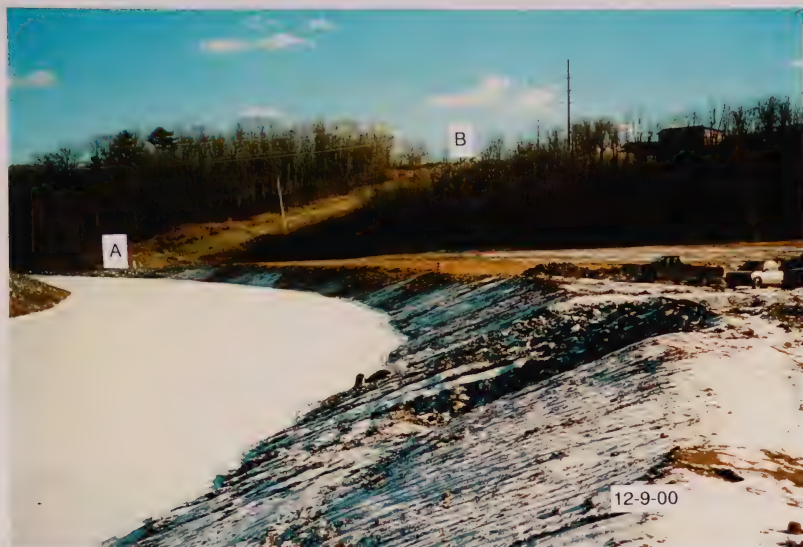
PHOTO 11: LOOKING SOUTHEAST. COUNTER BERM PLACED AGAINST TOE OF LANDSLIDE (RIGHT FOREGROUND). POWERLINE EASEMENT IN LEFT CENTER. JIFFY LUBE UPPER RIGHT. REALIGNED NORMANS KILL STREAM IN LEFT FOREGROUND.

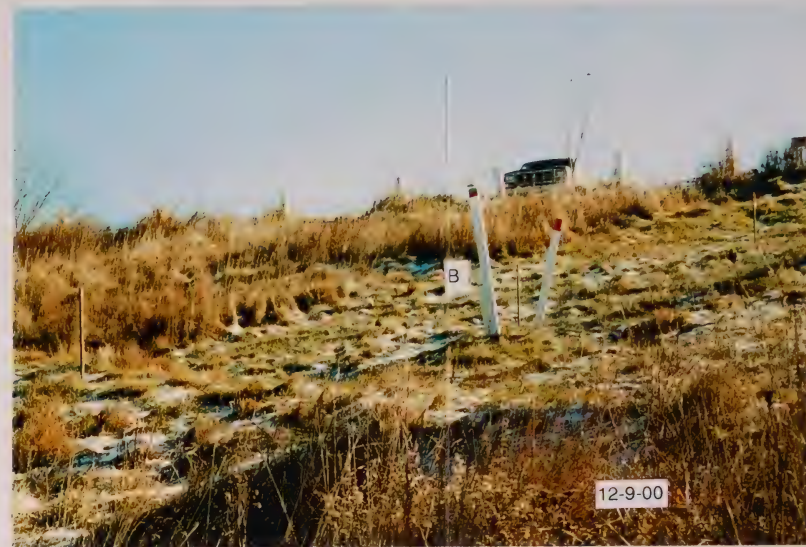
PHOTO 12: LOOKING SOUTH AT WHITE PIPES (B ON PHOTOGRAPH) MARKING GAS PIPELINE EASEMENT, UPPER SLOPE. JIFFY LUBE PARKING LOT ON TOP.

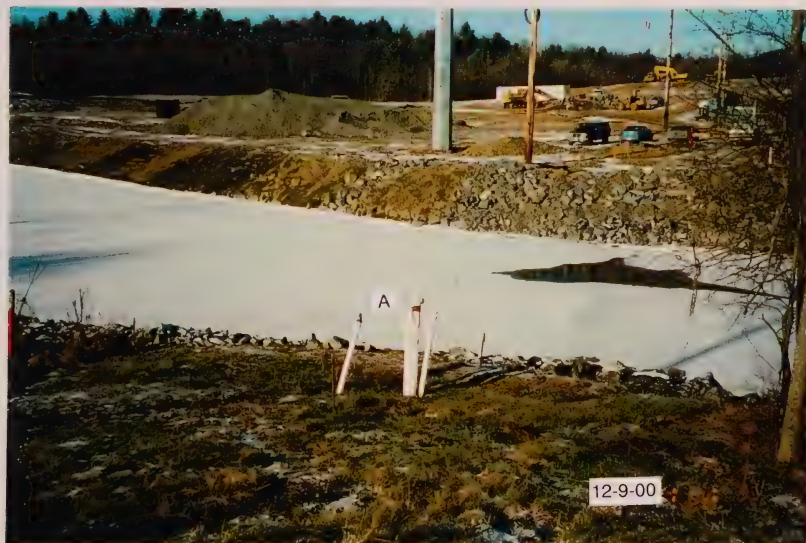
PHOTO 13: WHITE PIPES (A ON PHOTOGRAPH) MARKING GAS PIPELINE EASEMENT. NOTE NEW RIPRAP PROTECTION BOTH SIDES OF STREAM.

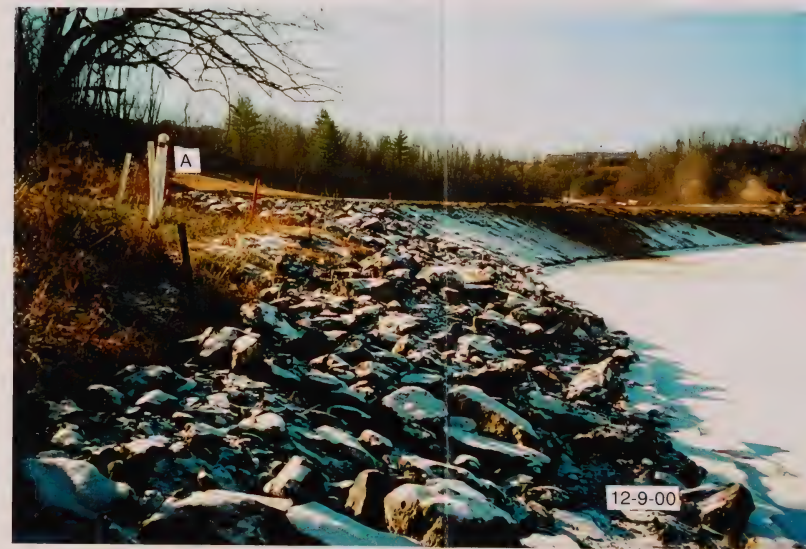
PHOTO 14: LOOKING WEST. NEW RIPRAP ALONG STREAM CHANNEL IN FOREGROUND NEW COUNTER BERM FILL WITH RIPRAP IN CENTER PHOTO.

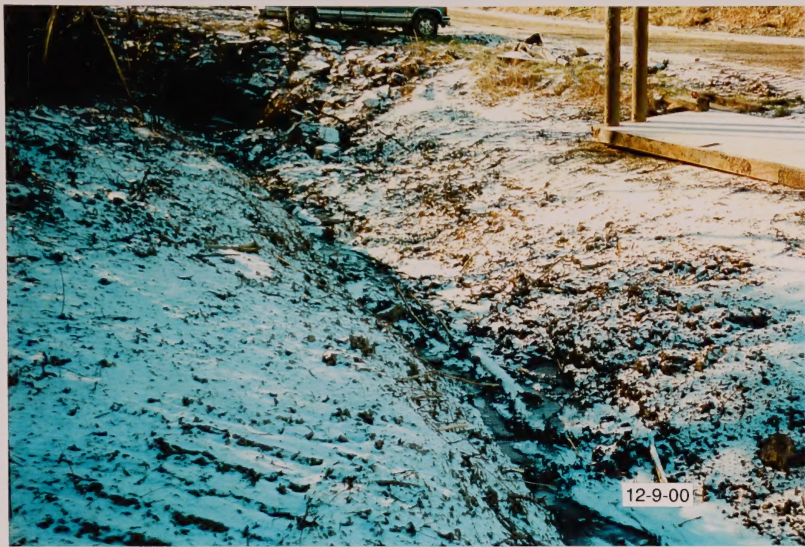
PHOTO 15: LOOKING EAST AT CULVERT NEAR ALBANY WATER PIPELINE EASEMENT.

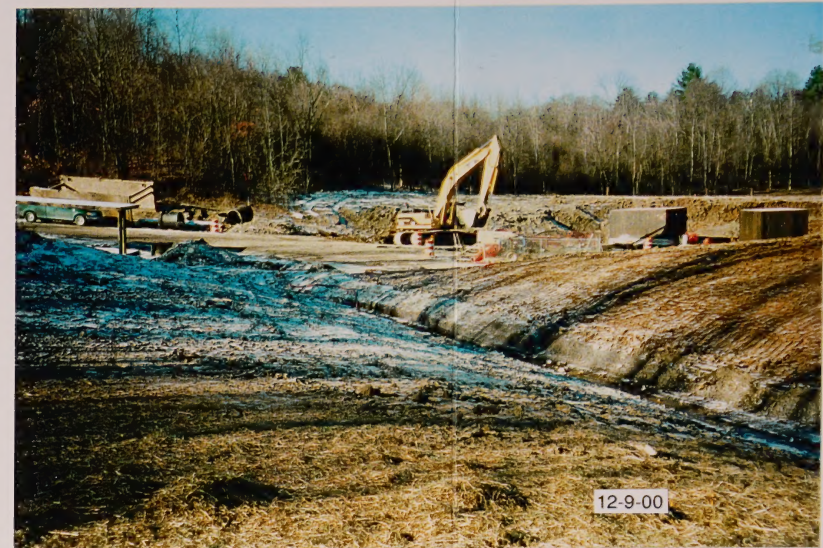
PHOTO 16: LOOKING EAST AT DRAINAGE DITCH FROM CULVERT NEAR ALBANY WATER PIPELINE EASEMENT. NOTE THE PIPELINE CONSTRUCTION NEAR BACKHOE.

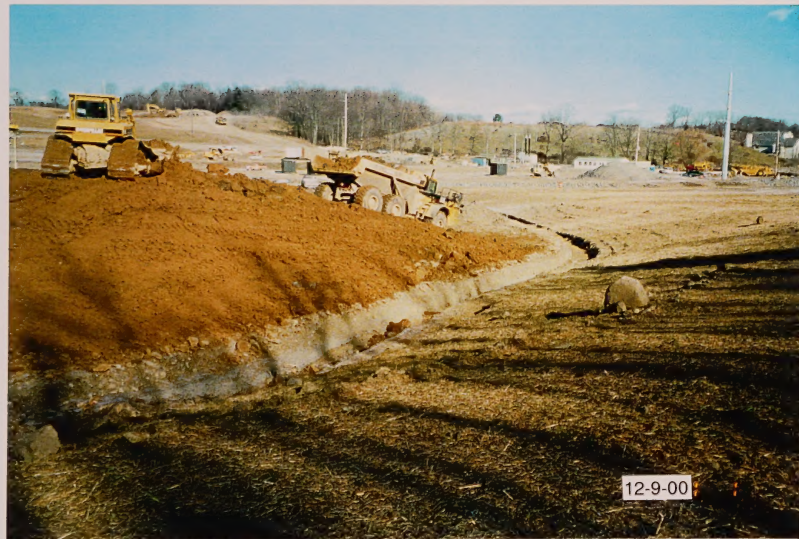
The slope below the Albany Medical Center (Corporate Finance Building) did not exhibit recent slide cracks or slumping. A small drainage channel travels down the slope, ending at the new counterberm fill where a small puddle forms. There were no significant seepage areas observed: apparently the counterberm fill has covered the wet areas observed in May and June. Survey monitoring data was not provided. The large counterberm and riprap placed at the relocated stream bank add resistance to the toe of this slope and make it more stable than before. Photos 1, 2, and 4 show the old slide features and the counterberm and buttress near the west edge of the slide. Photos 15 through 18 show construction features to the west of the slide toe, where the counterberm matches into the existing slope and accommodates a drainage ditch and the City of Albany construction to replace the water pipeline.

PHOTO 17: LOOKING NORTHEAST. DRAINAGE DITCH FROM CULVERT NEAR ALBANY WATER PIPELINE EASEMENT FLOWS THROUGH NEW COUNTER BERM PLACED AGAINST SLIDE TOE.

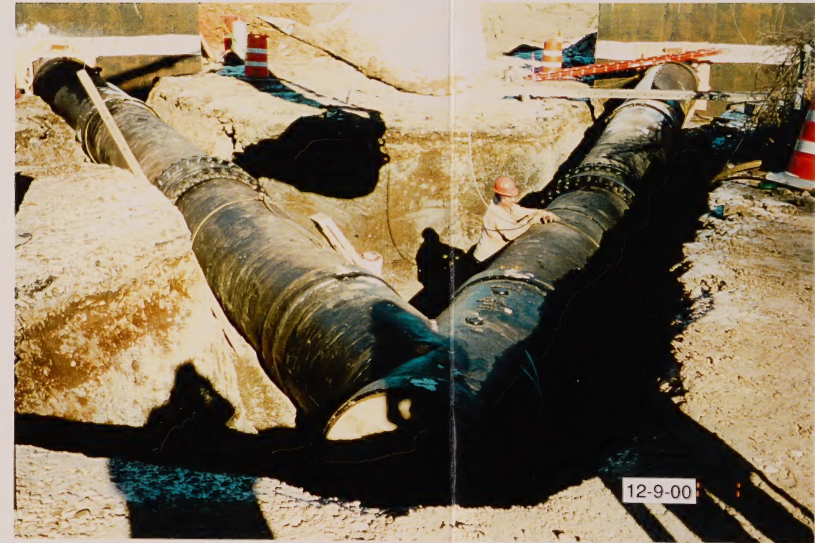
PHOTO 18: LOOKING NORTH. ALBANY PIPELINE 'Y' FITTING.
